Reading a TSK flow meter:

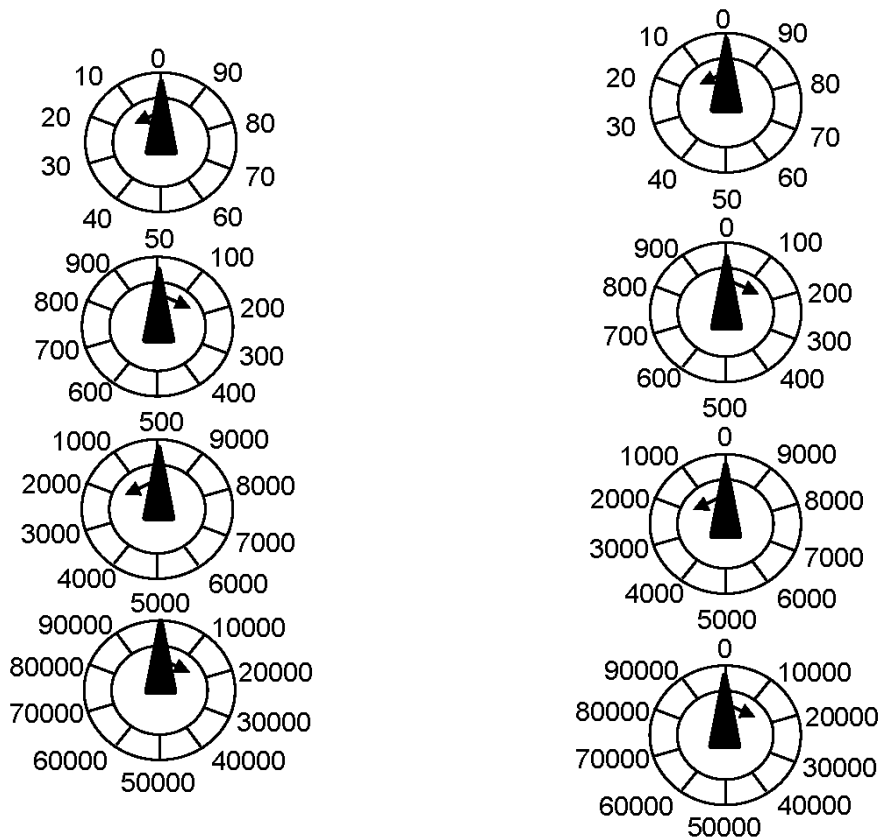
- 1) The flow meter should be reset PERFECTLY to zero on all dials before each deployment as shown below (rotate dials up to 0 by hand).
- 2) Although the meter shows the dial numbering on the LEFT below, they should show the numbering as on the RIGHT (note the added 0s at the zero position of each dial). I.e., each dial starts at 0 and rotates continuously toward higher numbers.

- 3) Start by reading the bottom dial and work up. See examples on next page. Because dials rotate continuously, every dial will show some reading after a tow, but a dial doesn't "count" until it's gone at least *past* its first tick (past 10 on the first dial, past 100, etc.). You will rarely if ever get a reading from the bottom dial: most readings for vertical tows will be between 100-1500 revolutions.

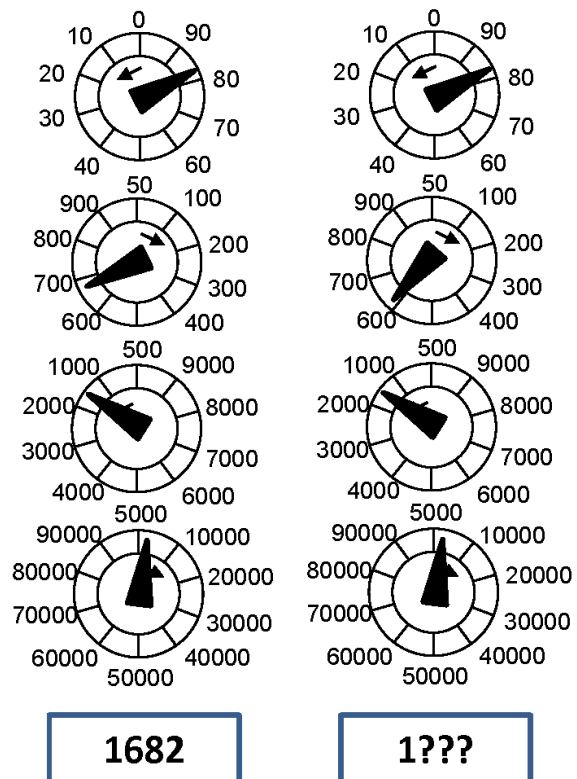
IMPORTANT -- Note these two slightly different readings.

The one on the *left* is **1682**.

But the reading on the *right* is not possible and means that the dials were not all perfectly zeroed before deployment.

What's wrong with it? The top two dials are inconsistent – for a reading of 82 on the top dial to be correct, the reading on the 2nd dial should either be *almost* to the 600 or *almost* to the 700, not just past 600.

So what's the correct reading? That's very hard to tell, and emphasizes the importance of zeroing perfectly to begin with. In this case, the higher-order dial is probably the one that's off because it would be caused by a smaller mistake when zeroing i.e., the actual reading is probably **1582**. You will have to use some judgment when there's an error like this, so it's best to draw the dial positions on the log sheet and interpret in whichever way is *most likely* given other readings for similar tow depths and the smallest probably zeroing error.
